High Volume/Low Speed Fan and Sprinkler Operation Phase II Research Program

Final Report

Aon Fire Protection Engineering

January 14, 2011

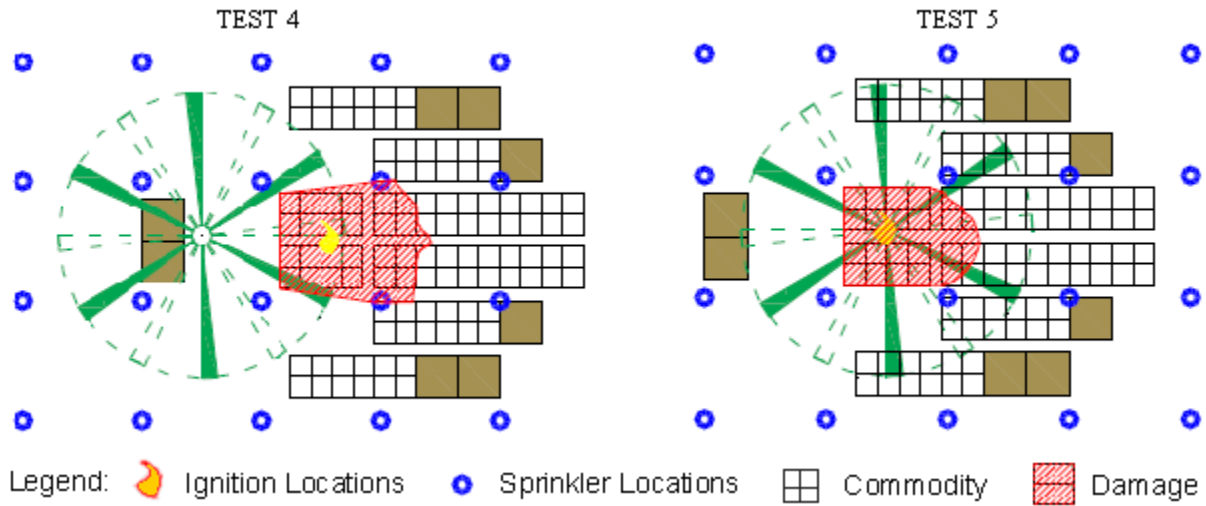
Figure 13. Tests 4 and 5 Damage Diagrams (Courtesy of UL)

In Tests 4 and 5 (UL-1 and UL-2), palletized storage array with a storage height of 15 feet was tested. The HVLS fan operated at full speed the entire duration of both tests. In Test 4 (UL-1), the ignition location was near the fan tip and in Test 5 (UL-2), the ignition was located under the hub. Both were successful, activating six sprinklers with acceptable damage.

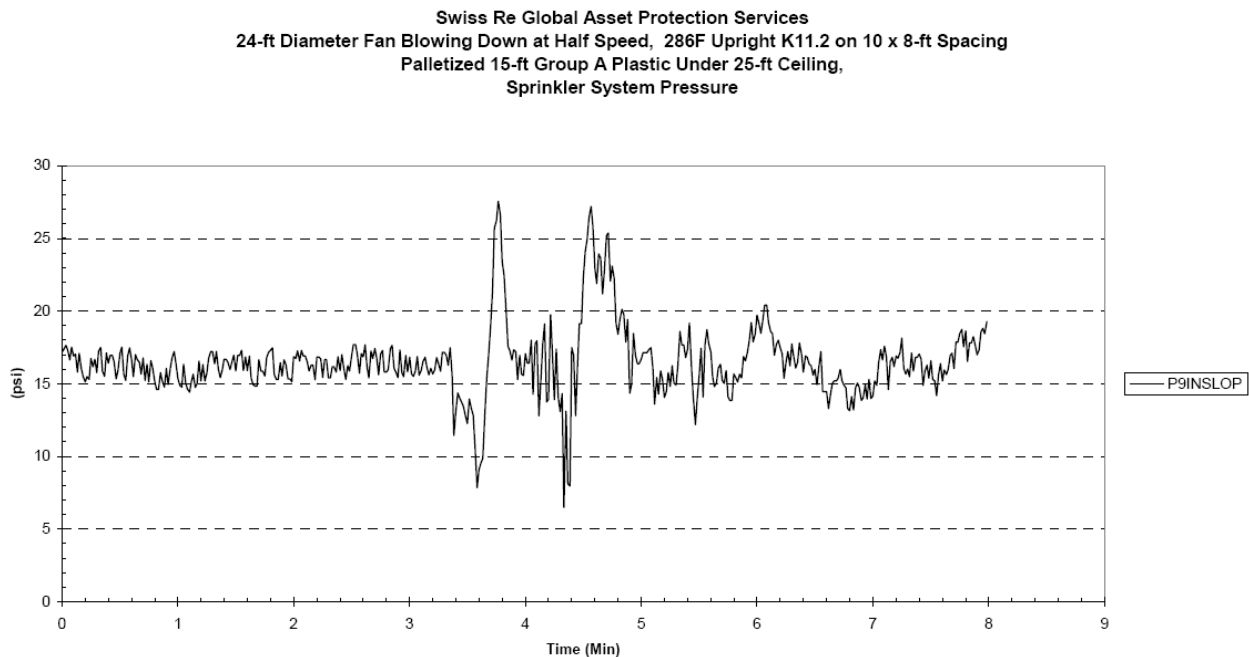
Figure 15. 2007 XL GAPS Test 1 Sprinkler Pressures (Courtesy of UL)

Review of the sprinkler discharge pressures of the 2007 XL GAPS Test 1 (Figure 15) showed that the pressure required to provide a 0.60 gpm/sq.ft sprinkler density, 18 psi, was provided when the first two sprinklers simultaneously activated at 3:26 minutes. However, after that point the water pressure decayed so that the next three sprinklers (which operated at 3:28, 3:39, and 3:42 minutes) were provided with a reduced pressure in the range of 8-14 psi. This resulted in sprinkler densities of approximately 0.40-0.52 gpm/sq.ft for these sprinklers. The water pressure increased back to 18 psi, but again another decrease in pressure below 18 psi occurred at approximately 4:15 minutes. This fluctuation of the water pressure resulted in the sprinkler densities below that establish for the testing.

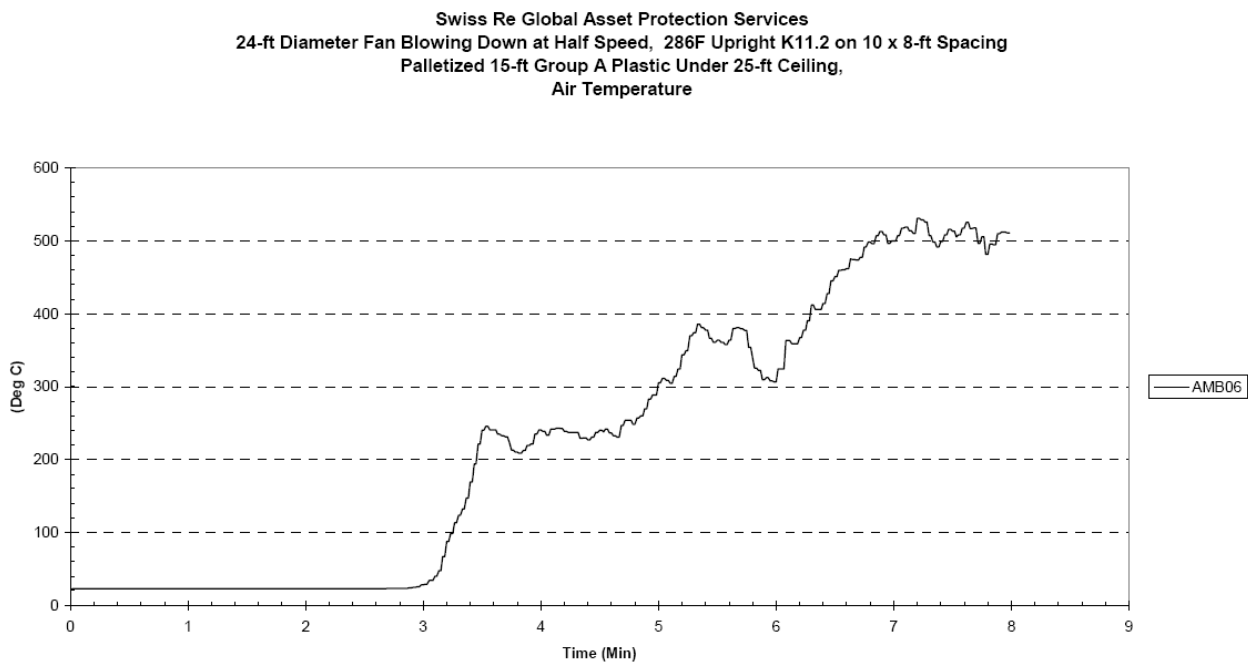
Figure 17. 2007 XL GAPS Test 1 Air Temperature (Courtesy of UL)

Comparison of the ceiling temperature data of Tests 6-8 (UL-3-5) and the 2007 XL GAPS Test 1 showed no similarities. However, the data from the 2007 XL GAPS Test 1 (Figure 17) showed low initial temperatures until approximately 3 minutes at which time the temperature begins to rise, which is indicative of prolonged incipient and fast upward fire spread phases.

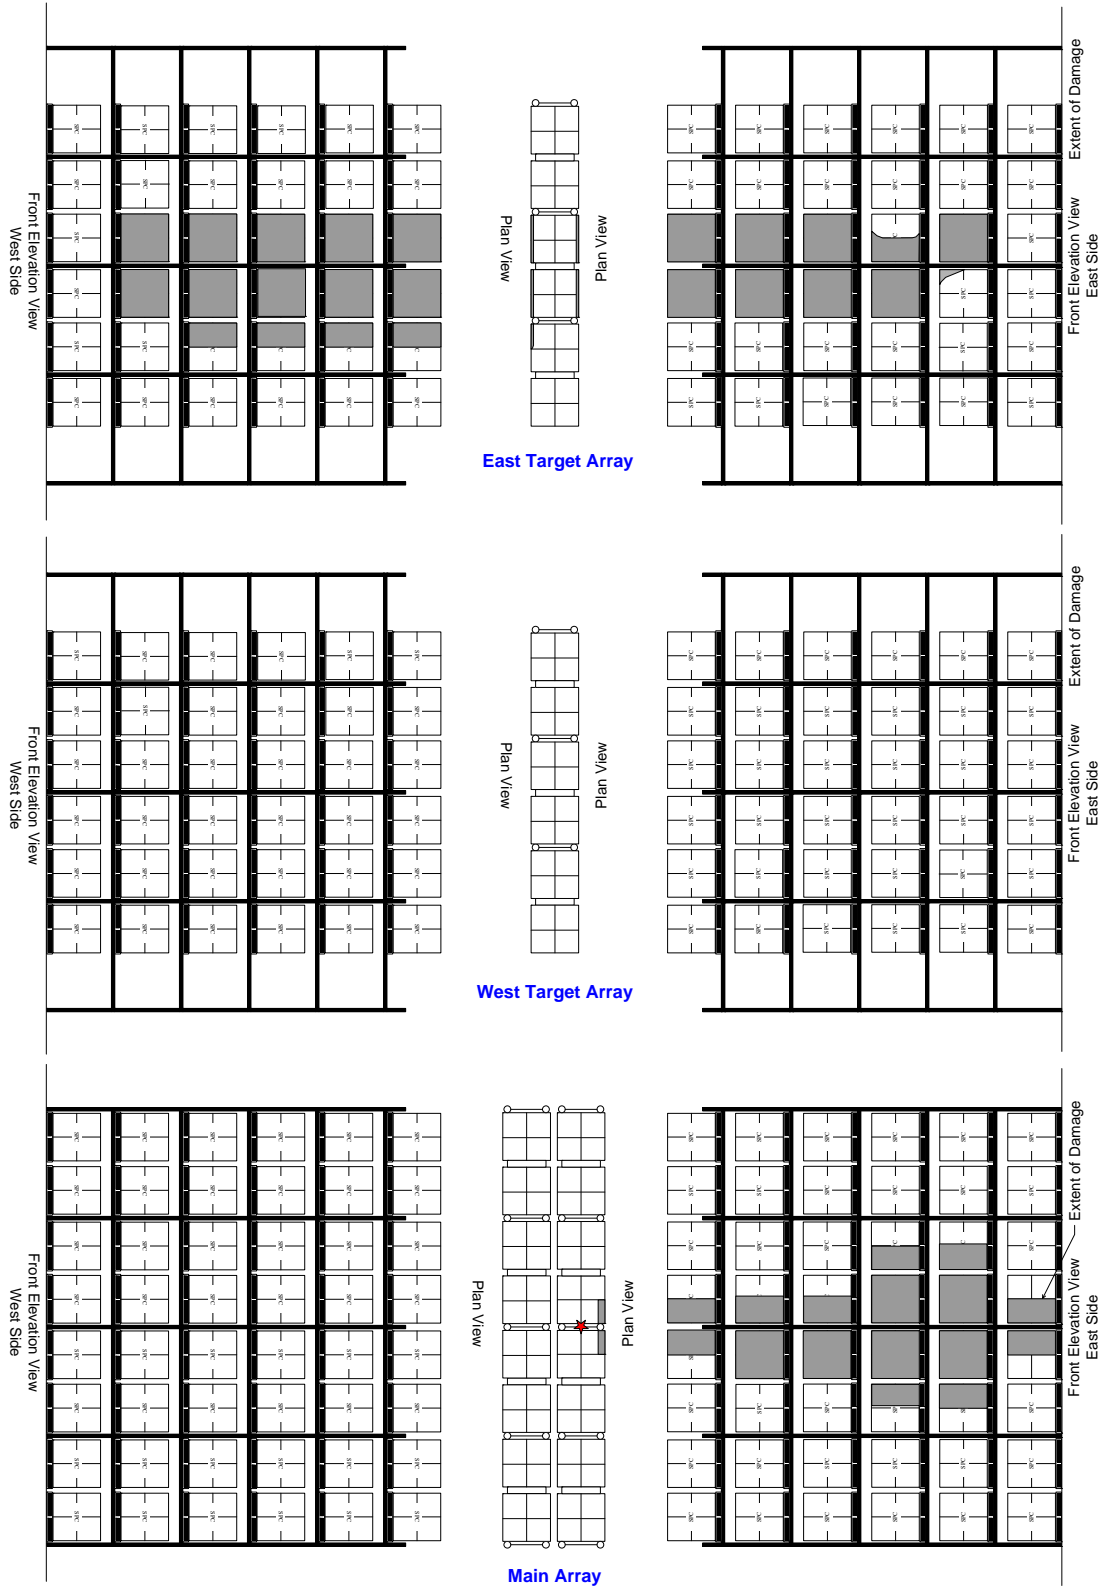
Damage to Commodity (Equivalent of 4.5 pallets loads consumed)

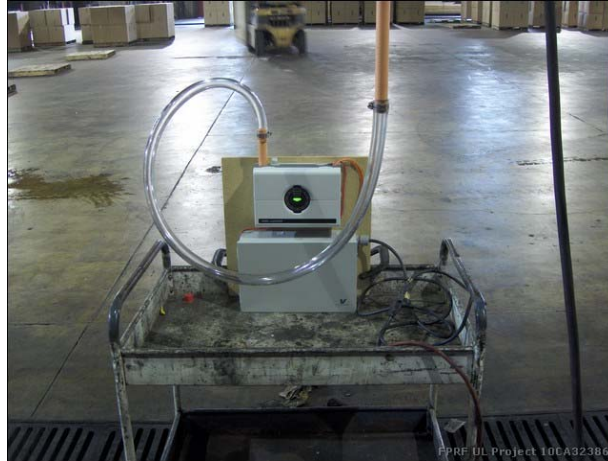
Figure 9 VESDA Control Unit

For tests 3, 4 and 5, a VESDA “Laser FOCUS” smoke detection system was installed. This installation consisted of a 4 ft. horizontal 1 in. CPVC sampling tube, mounted 18 in. above the fan motor. A 1 in. by 1 in. by 1 in. TEE at the center of the sampling tube supplied approximately 75 ft. of 1 in. CPVC piping to the VESDA control unit. The sampling tube is shown in Figure 8. The reported sensitivity settings for the VESDA control unit (Figure 9) were as follows:

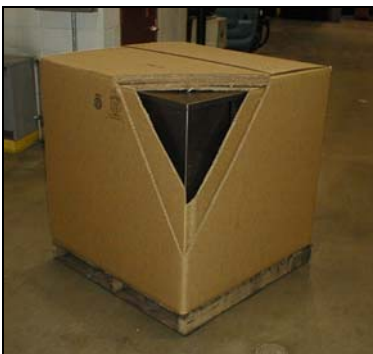
Figure 12 Class II Commodity

The Class 2 commodity was constructed from double tri-wall corrugated cardboard cartons with five sided steel stiffeners inserted for stability. Outer carton measurements were 42 by 42 by 42-in. tall on a single 42 by 42 by 5-in. tall hardwood two-way entry pallet. A photo of the Class II commodity is shown in Figure 12.

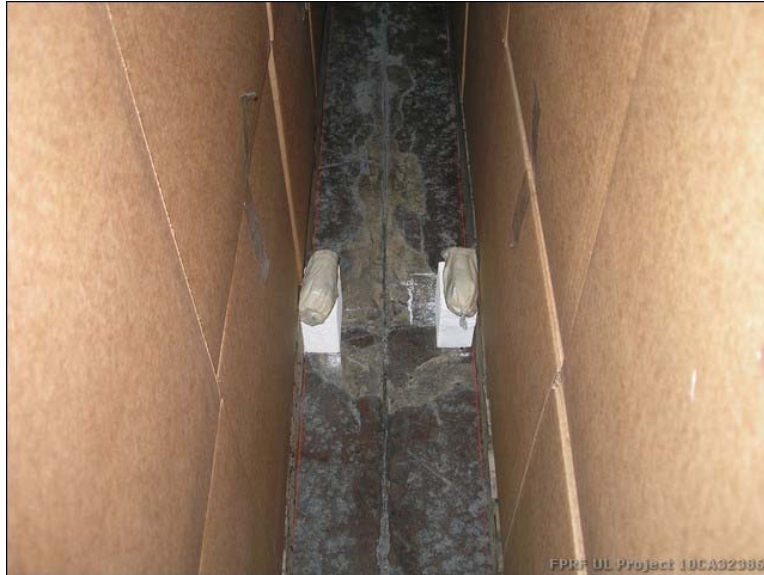
Figure 16 Test 1 Ignition Detail

Ignition was accomplished by using two full-standard cellulose cotton igniters. The igniters were constructed from 3 in. by 6 in. long cellulosic bundles each soaked with 8 oz. of gasoline and wrapped in a polyethylene bags. The igniters were positioned 4 1/2-in off the floor and located in the longitudinal flue at the center of the main array, as shown in Figure 16.

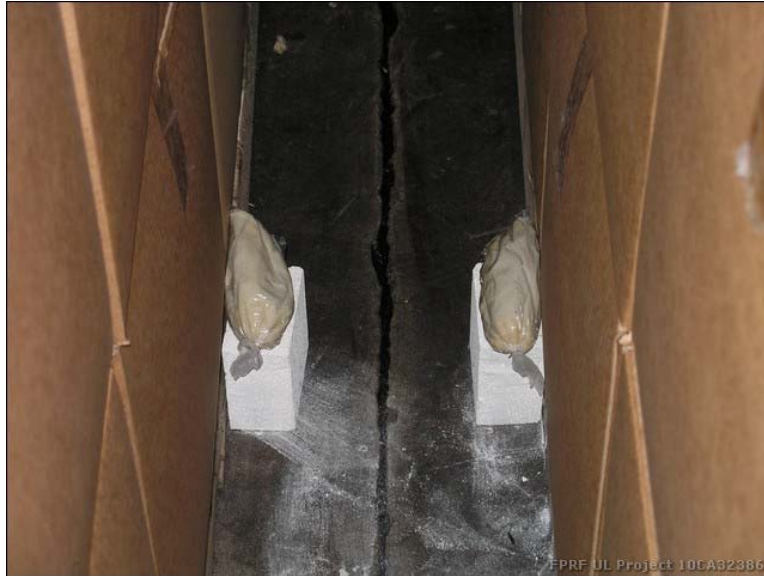
Figure 20 Test 2 Ignition Detail

Ignition was accomplished by using two full-standard cellulose cotton igniters. The igniters were constructed from 3 in. by 6 in. long cellulosic bundles each soaked with 8 oz. of gasoline and wrapped in a polyethylene bags. The igniters were positioned 4 1/2-in off the floor and located in the longitudinal flue at the center of the main array, as shown in Figure 20.

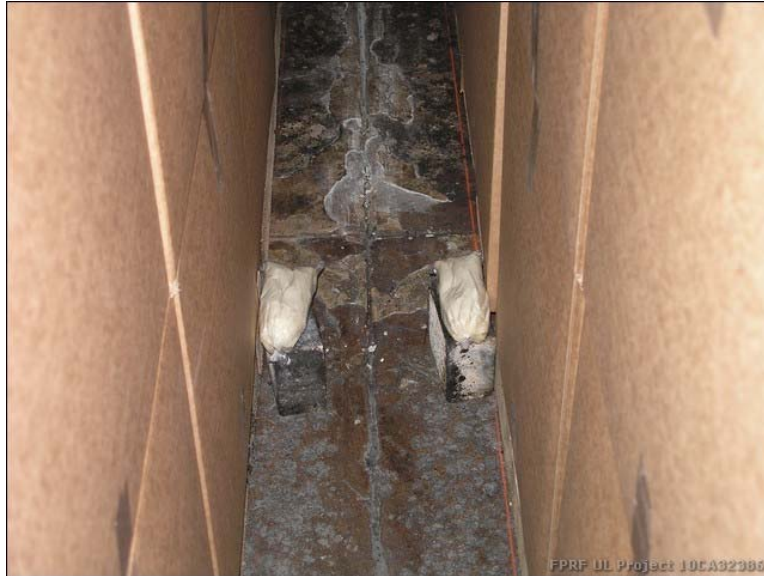
Figure 24 Test 3 Ignition Detail

Ignition was accomplished by using two full-standard cellulose cotton igniters. The igniters were constructed from 3 in. by 6 in. long cellulosic bundles each soaked with 8 oz. of gasoline and wrapped in a polyethylene bags. The igniters were positioned 10-in off the floor and located in the longitudinal flue at the center of the main array, as shown in Figure 24.

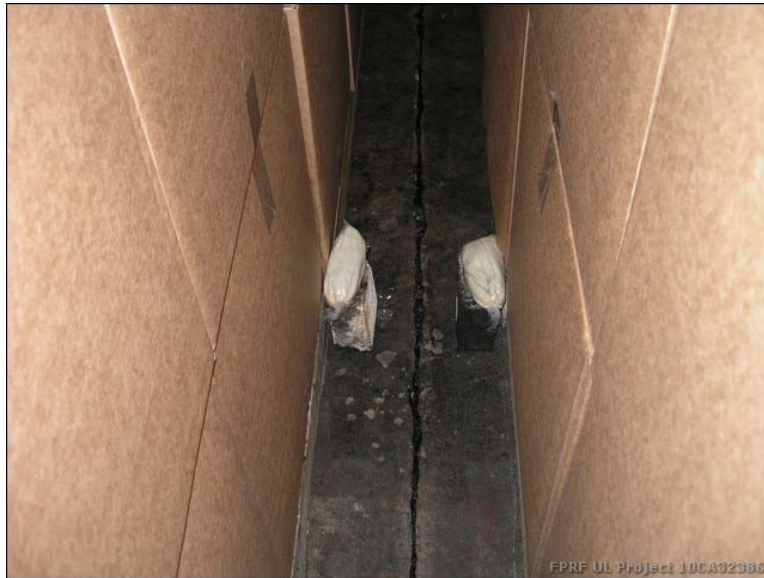
Figure 28 Test 4 Ignition Detail

Ignition was accomplished by using two full-standard cellulose cotton igniters. The igniters were constructed from 3 in. by 6 in. long cellulosic bundles each soaked with 8 oz. of gasoline and wrapped in a polyethylene bags. The igniters were positioned 10-in off the floor and located in the longitudinal flue at the center of the main array, as shown in Figure 28.

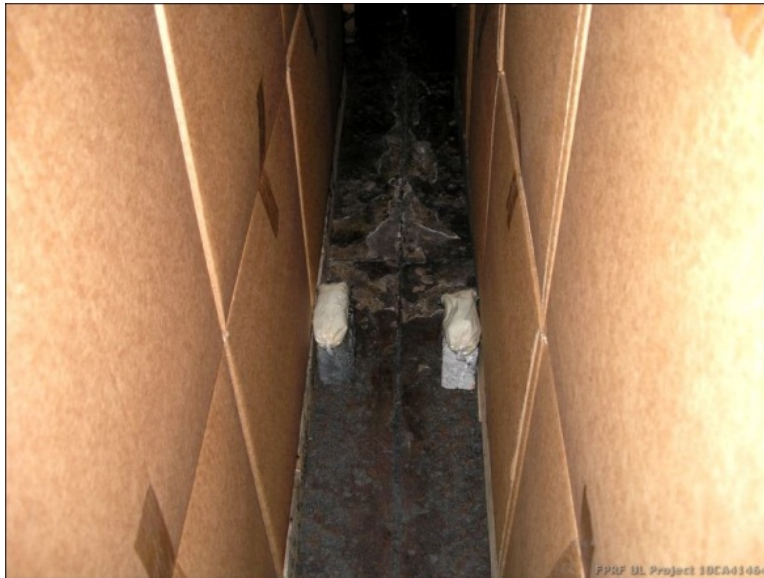
Figure 32 Test 5 Ignition Detail

Ignition was accomplished by using two full-standard cellulose cotton igniters. The igniters were constructed from 3 in. by 6 in. long cellulosic bundles each soaked with 8 oz. of gasoline and wrapped in a polyethylene bags. The igniters were positioned 4 1/2-in off the floor and located in the longitudinal flue at the center of the main array, as shown in Figure 32.

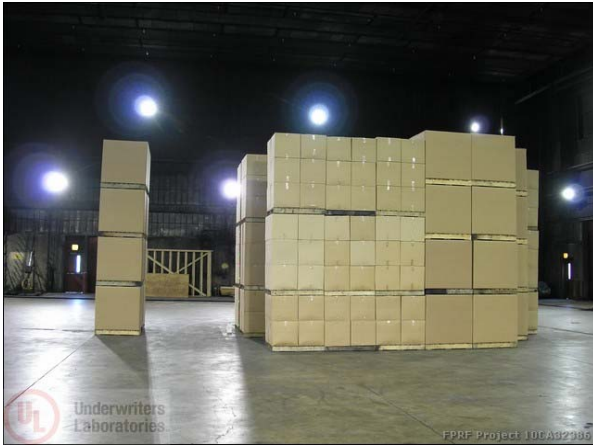
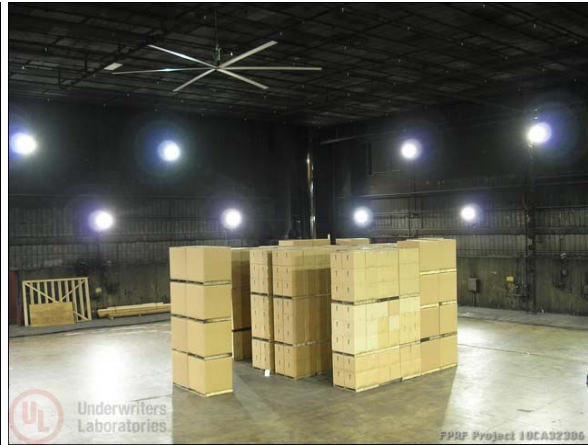
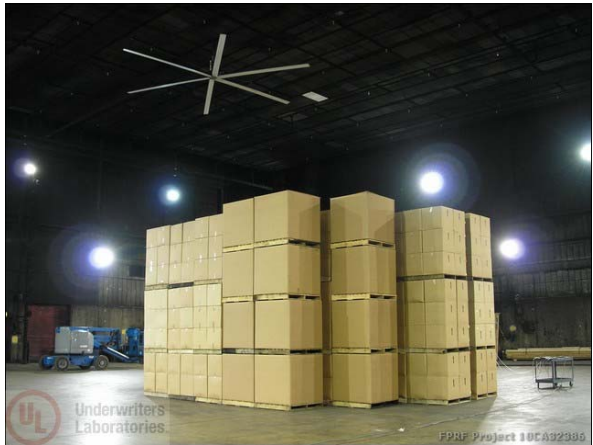
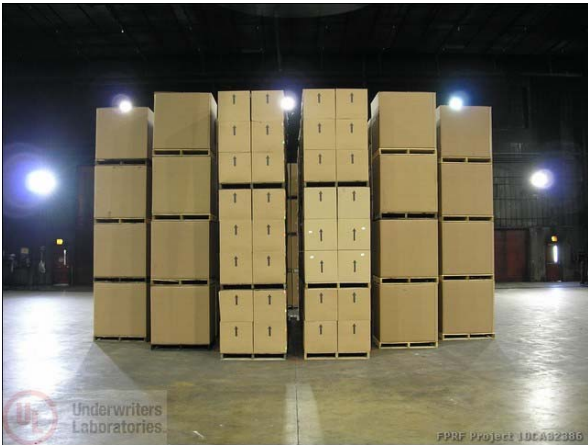
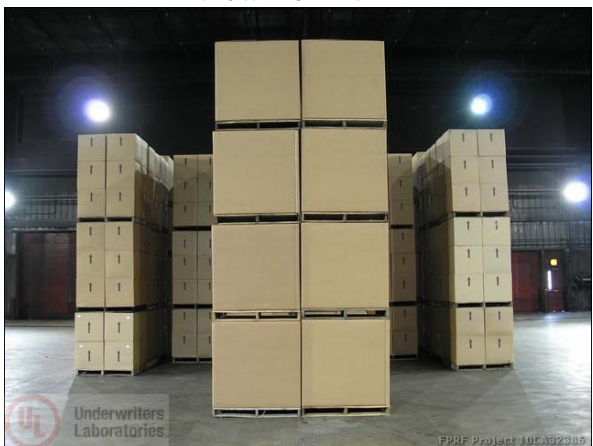
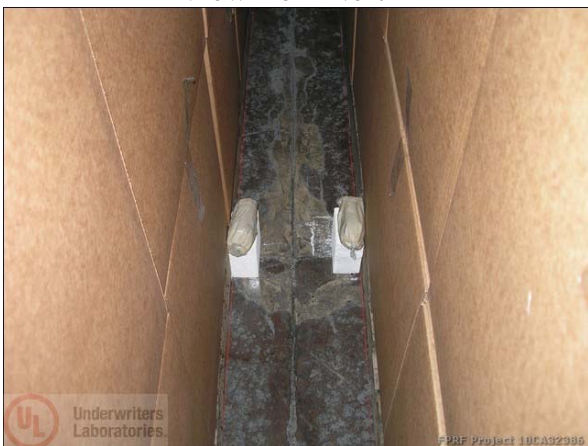
Figure 35 Test 1 Photos

The storage arrangement consisted of 20 stacks of Group A commodity and six stacks of Class II commodity. The stacks of Group A commodity were developed using three pallets and 32 cartons. The bottom palletized load contained a double course of four cartons while the top two palletized loads contained a triple course of four cartons. The stacks of Class II commodity were developed using four pallets with four box assemblies. These stacks were placed to have 12 in. flue spaces. Test setup photos are presented in Figure 35.

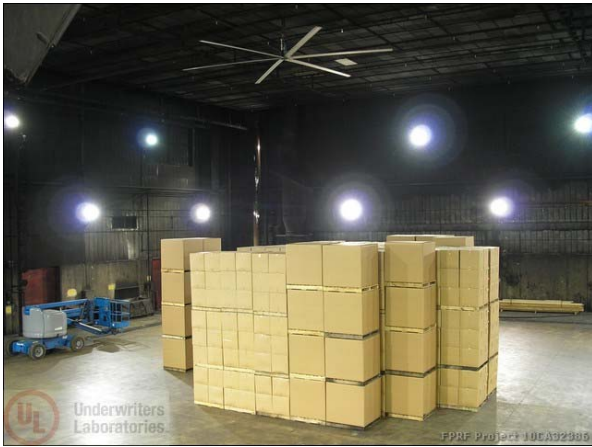
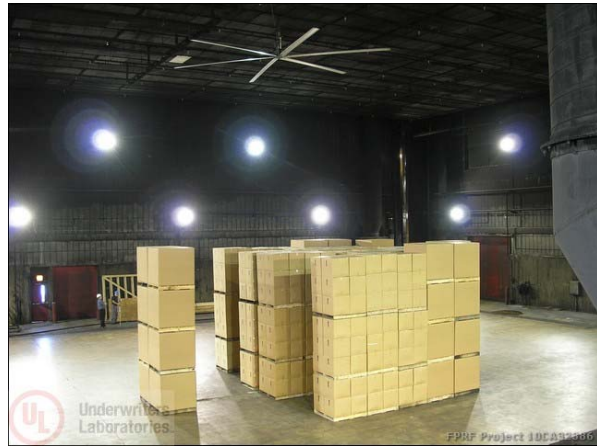
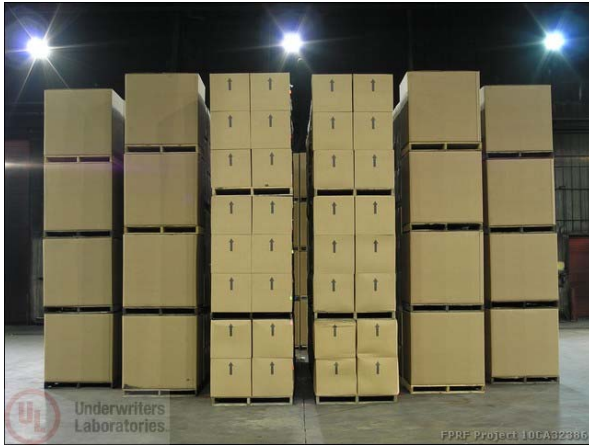
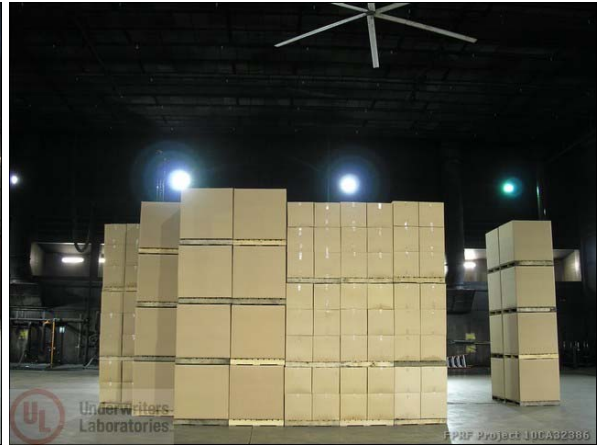
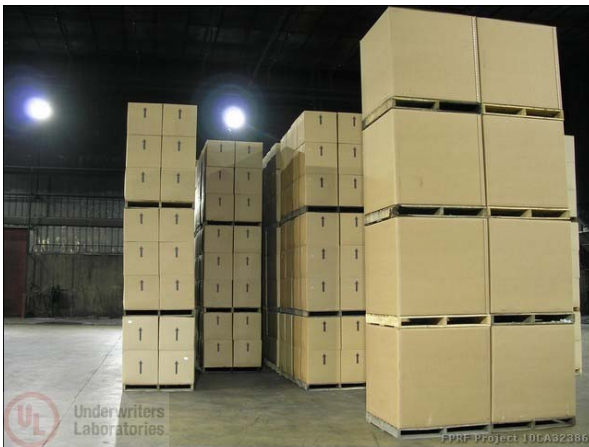
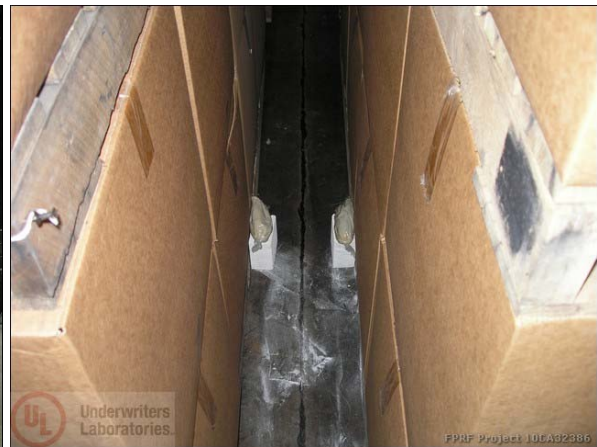
Figure 36 Test 2 Photos

The storage arrangement consisted of 20 stacks of Group A commodity and six stacks of Class II commodity. The stacks of Group A commodity were developed using three pallets and 32 cartons. The bottom palletized load contained a double course of four cartons while the top two palletized loads contained a triple course of four cartons. The stacks of Class II commodity were developed using four pallets with four box assemblies. These stacks were placed to have 12 in. flue spaces. Test setup photos are presented in Figure 36.

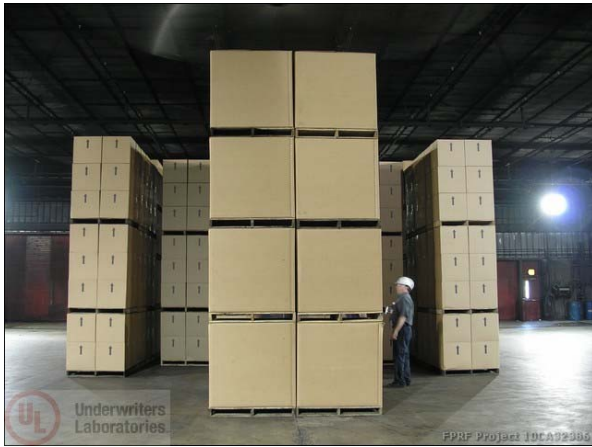
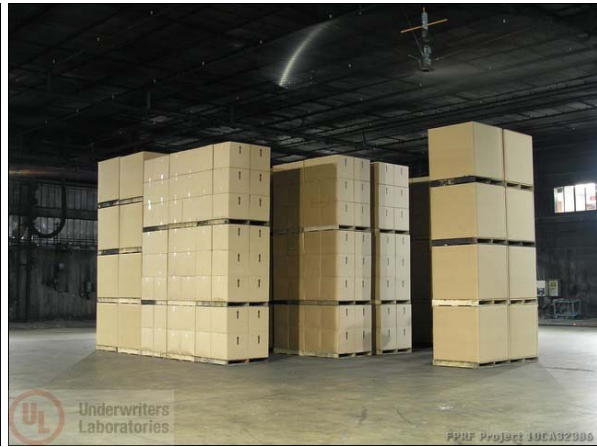
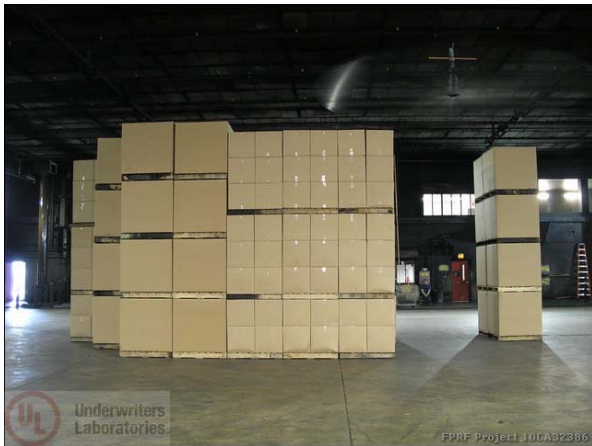
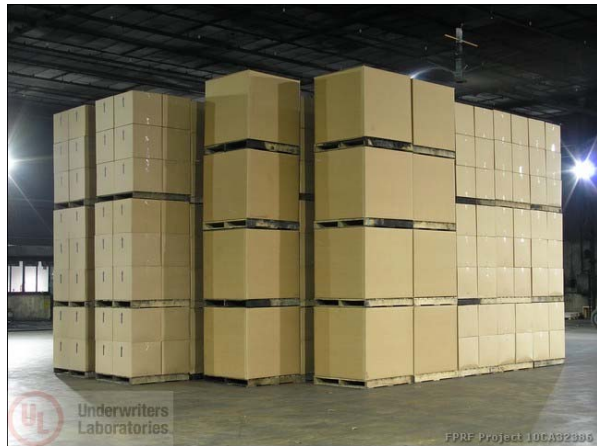
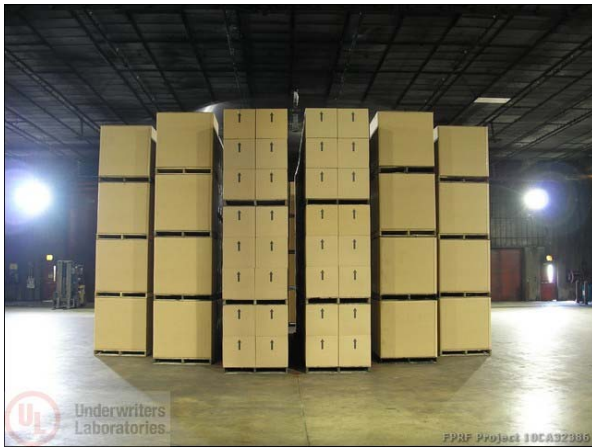
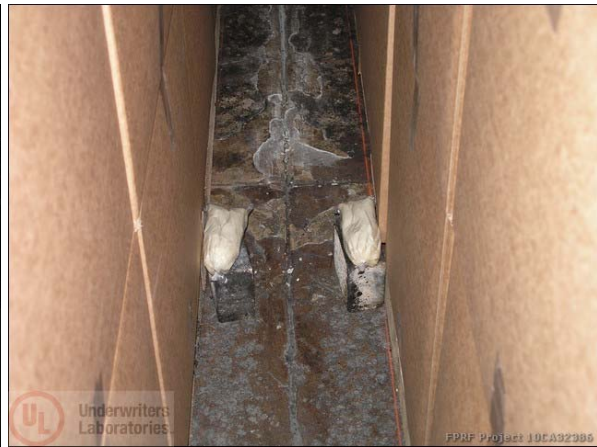
Figure 37 Test 3 Photos

The storage arrangement consisted of 20 stacks of Group A commodity and six stacks of Class II commodity. The stacks of Group A commodity were developed using three pallets and 32 cartons. The bottom palletized load contained a double course of four cartons while the top two palletized loads contained a triple course of four cartons. The stacks of Class II commodity were developed using four pallets with four box assemblies. These stacks were placed to have 12 in. flue spaces. Test setup photos are presented in Figure 37.

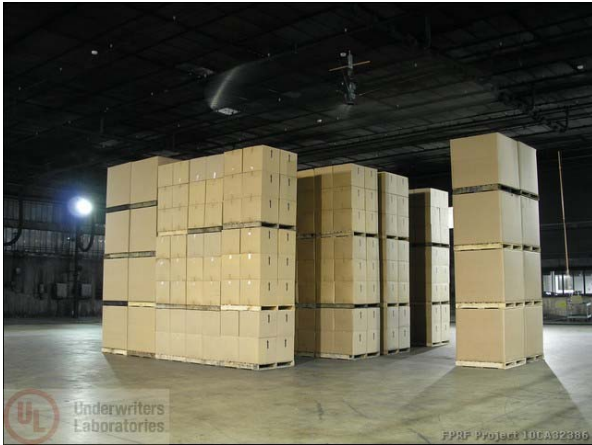
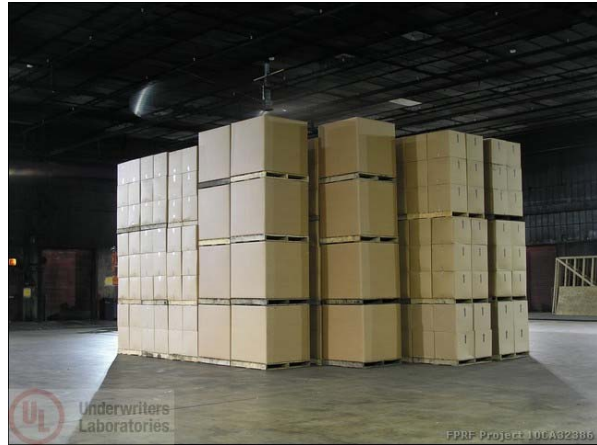
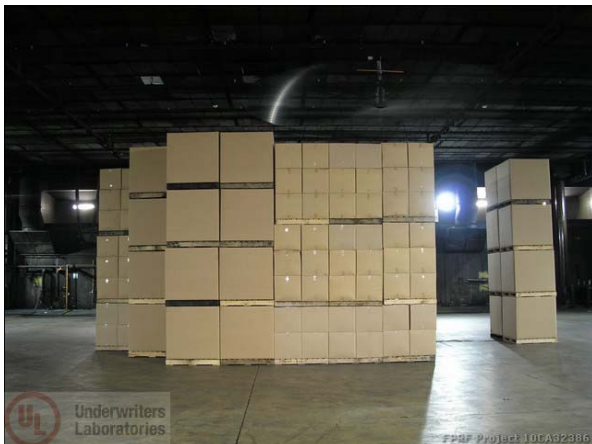
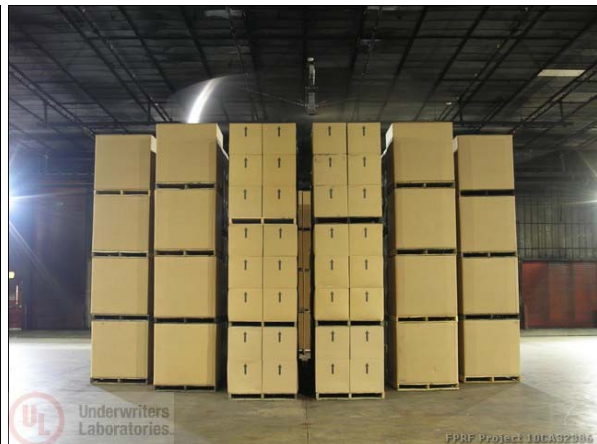
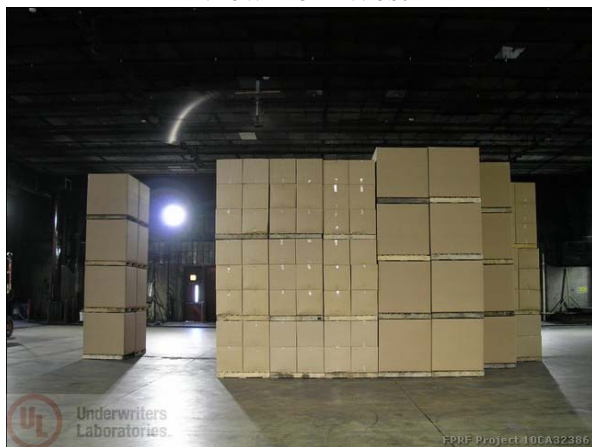
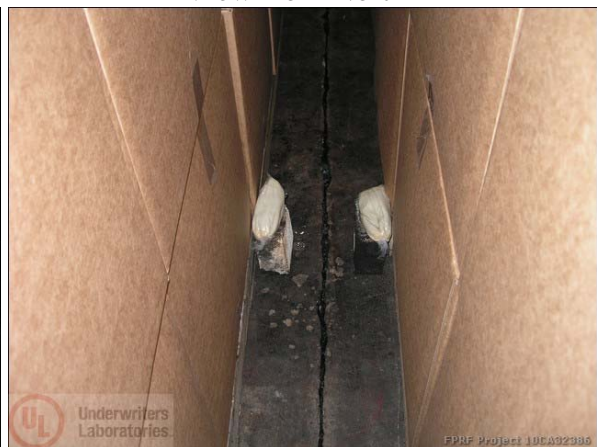
Figure 38 Test 4 Photos

The storage arrangement consisted of 20 stacks of Group A commodity and six stacks of Class II commodity. The stacks of Group A commodity were developed using three pallets and 32 cartons. The bottom palletized load contained a double course of four cartons while the top two palletized loads contained a triple course of four cartons. The stacks of Class II commodity were developed using four pallets with four box assemblies. These stacks were placed to have 12 in. flue spaces. Test setup photos are presented in Figure 38.

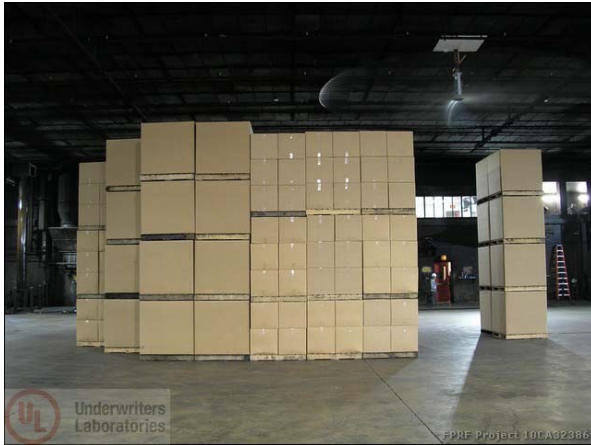
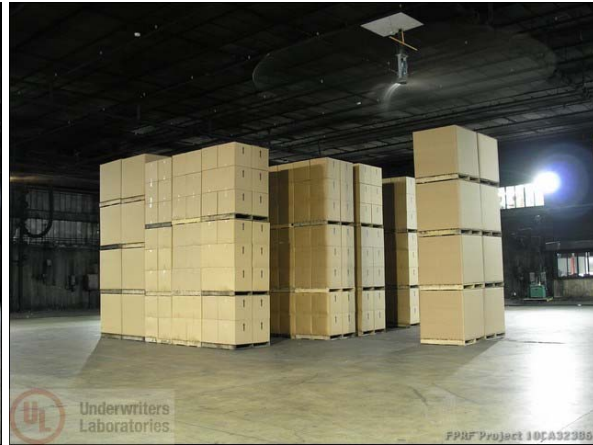
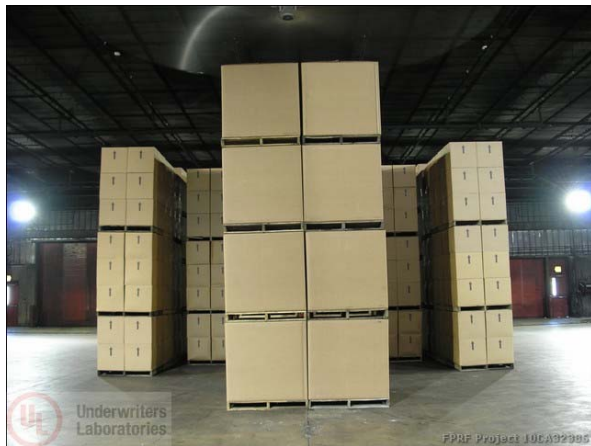
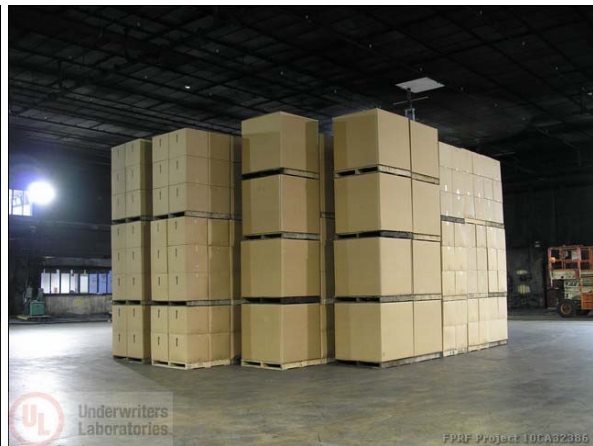
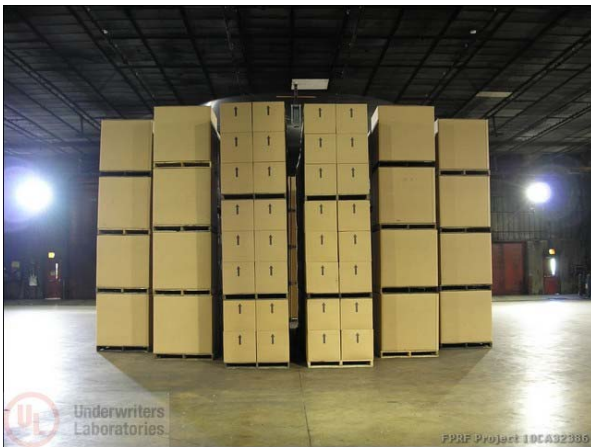
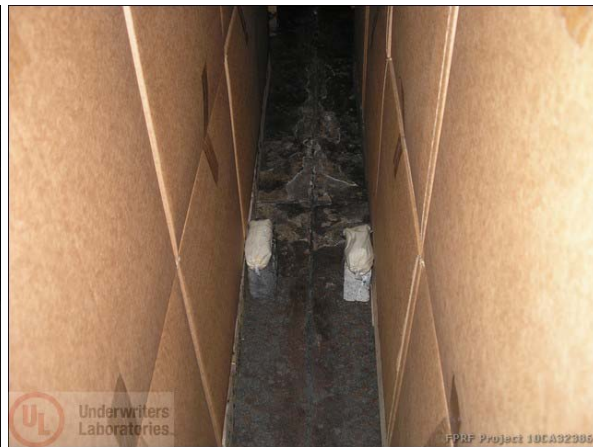
Figure 39 Test 5 Photos

The storage arrangement consisted of 20 stacks of Group A commodity and six stacks of Class II commodity. The stacks of Group A commodity were developed using three pallets and 32 cartons. The bottom palletized load contained a double course of four cartons while the top two palletized loads contained a triple course of four cartons. The stacks of Class II commodity were developed using four pallets with four box assemblies. These stacks were placed to have 12 in. flue spaces. Test setup photos are presented in Figure 39.

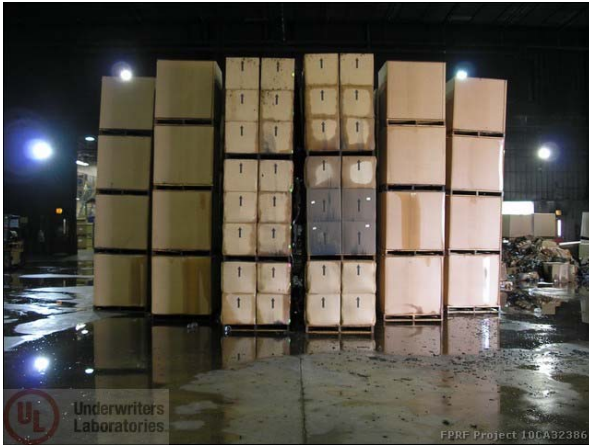
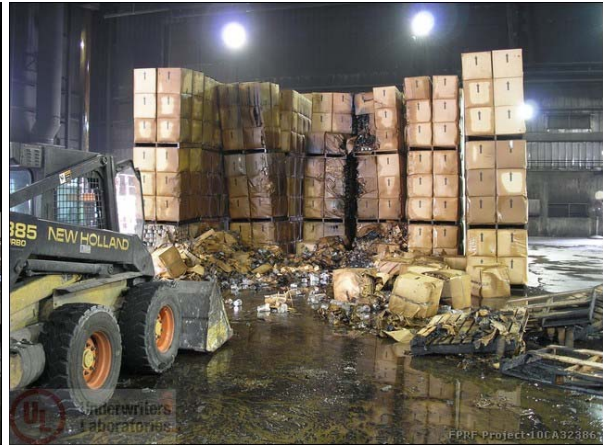
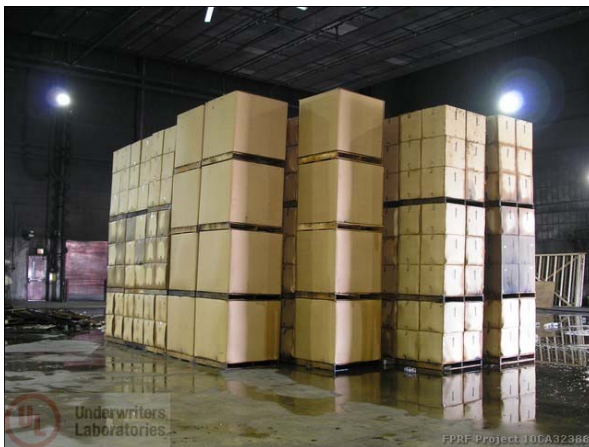
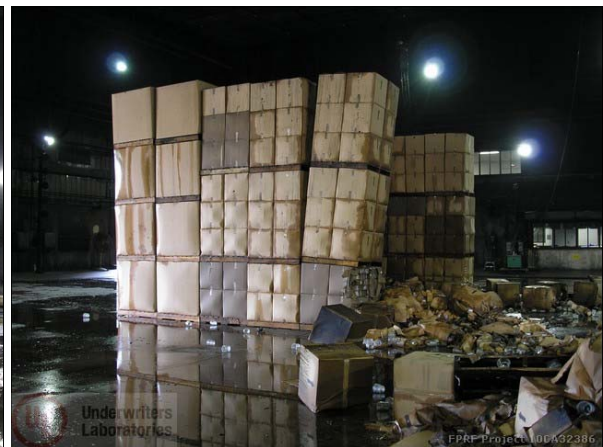
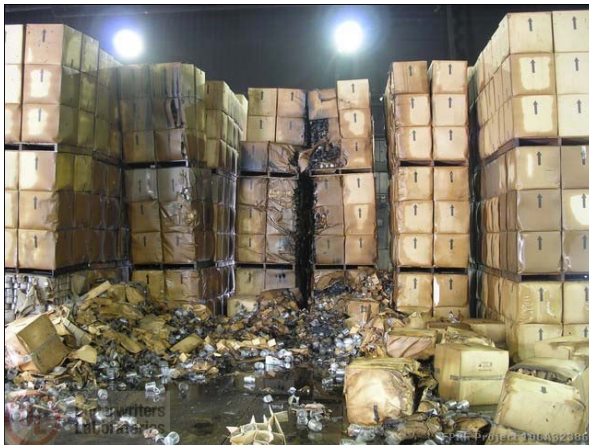
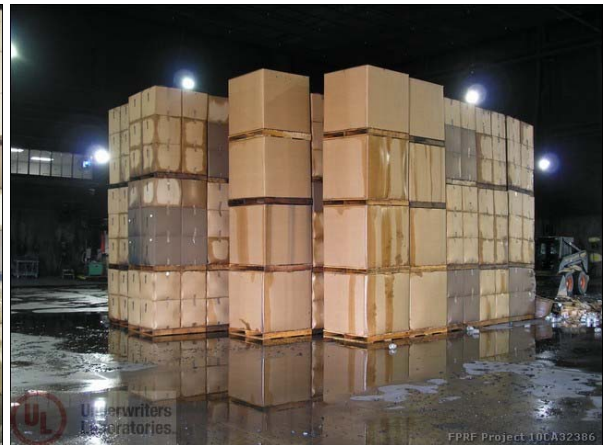
Figure 50 Post Test Photos – Test 1

View from North

View from South

View from NE

View from West

View above Ignition

Sprinkler operation times are presented in Figure 40, and a plan view of the extent of fire is presented in Figure 41. Post-test photos are presented in Figure 50. Tabulated test results are presented in Table 4. Temperature data vs. time charts are presented in Appendix A.

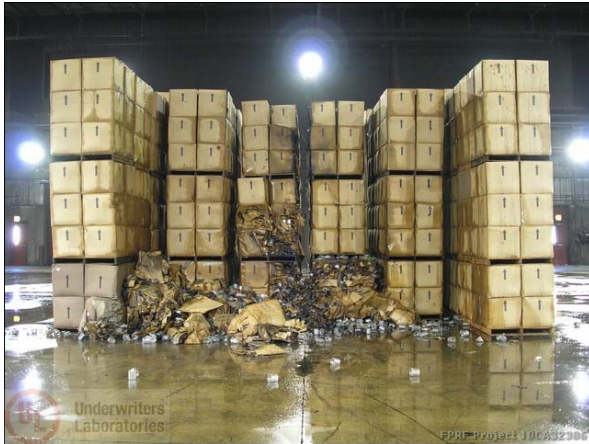
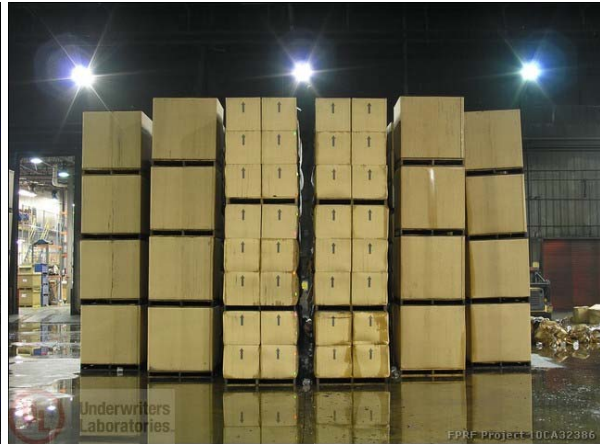
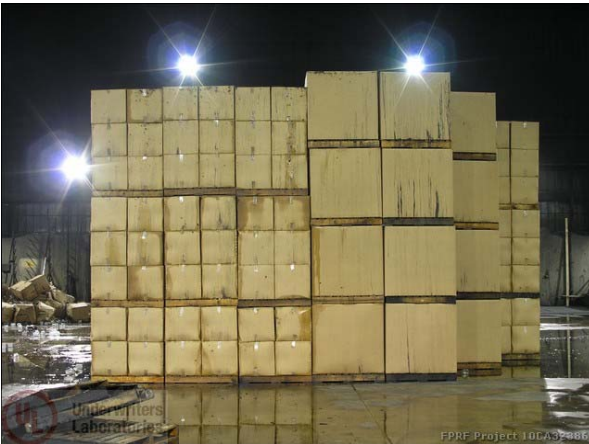
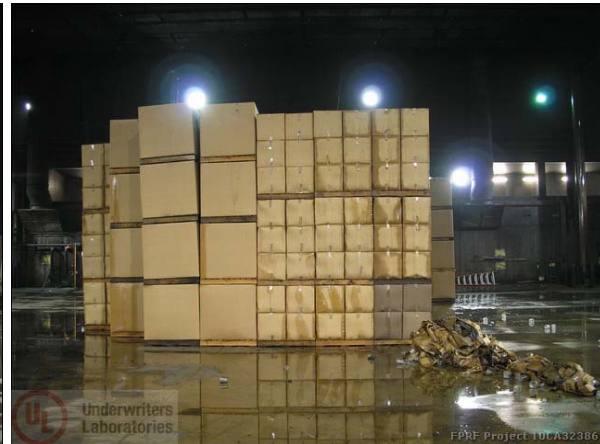
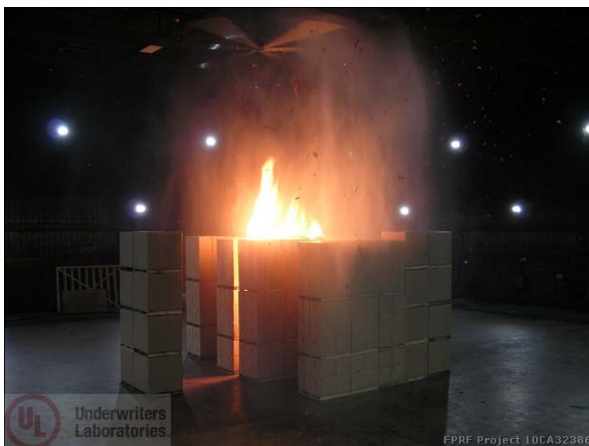
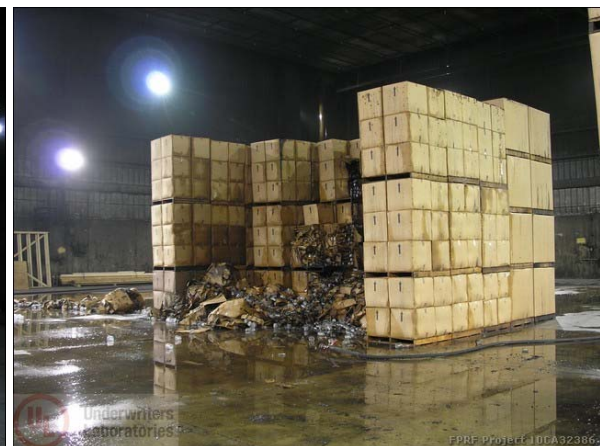
Figure 51 Post Test Photos – Test 2

View from South

View from North

View from East

View from West

View from SE balcony

View from SE

Sprinkler operation times are presented in Figure 42, and a plan view of the extent of fire is presented in Figure 43. Post-test photos are presented in Figure 51. Tabulated test results are presented in Table 4. Temperature data vs. time charts are presented in Appendix B.

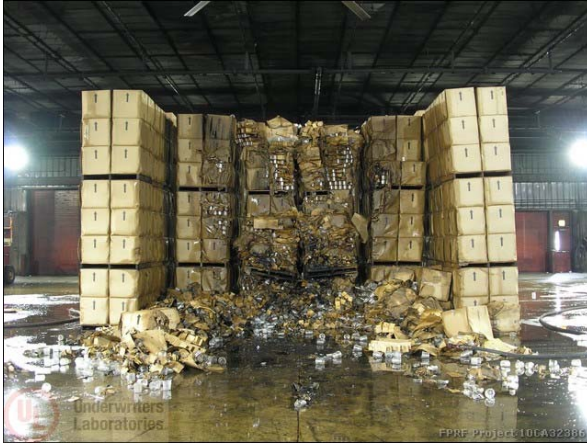
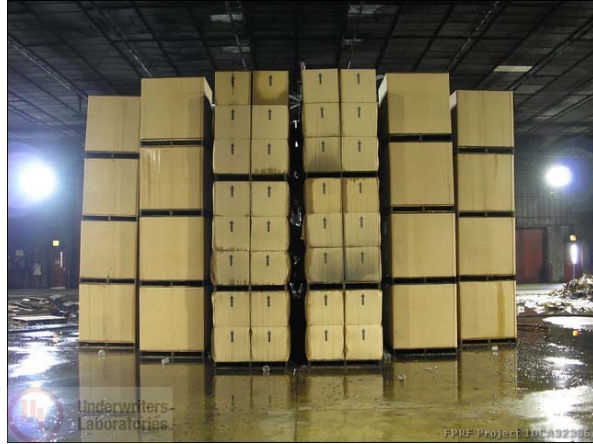
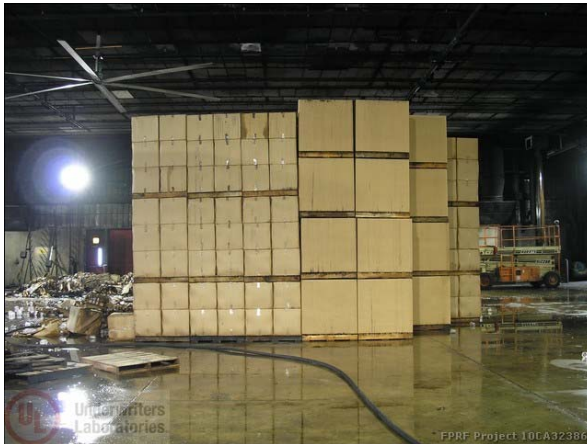
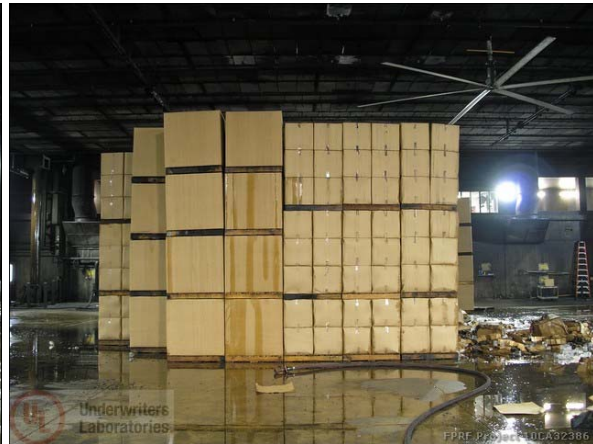
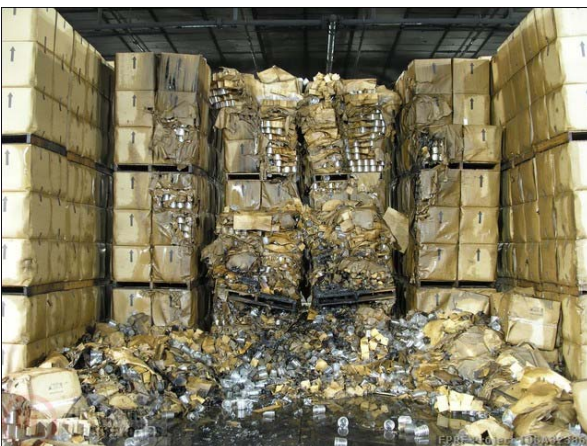
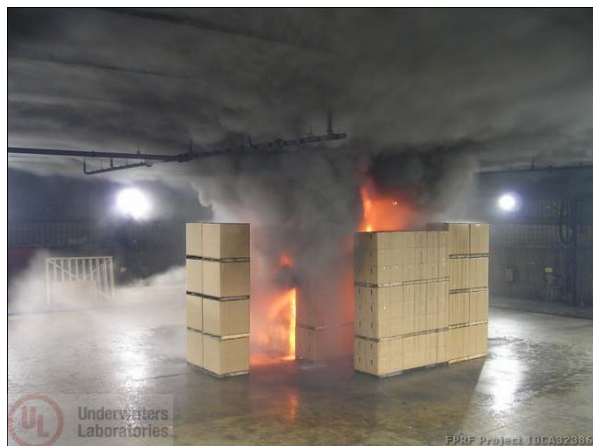
Figure 52 Post Test Photos – Test 3

View from South

View from North

View from East

View from West

View from SE balcony

Sprinkler operation times are presented in Figure 44, and a plan view of the extent of fire is presented in Figure 45. Post-test photos are presented in Figure 52. Tabulated test results are presented in Table 4. Temperature data vs. time charts are presented in Appendix C.
